HICKORY HOLLOW LAKE DAM

PERRY COUNTY, MISSOURI

MO 31068

PHASE 1 INSPECTION REPORT NATIONAL DAM SAFETY PROGRAM

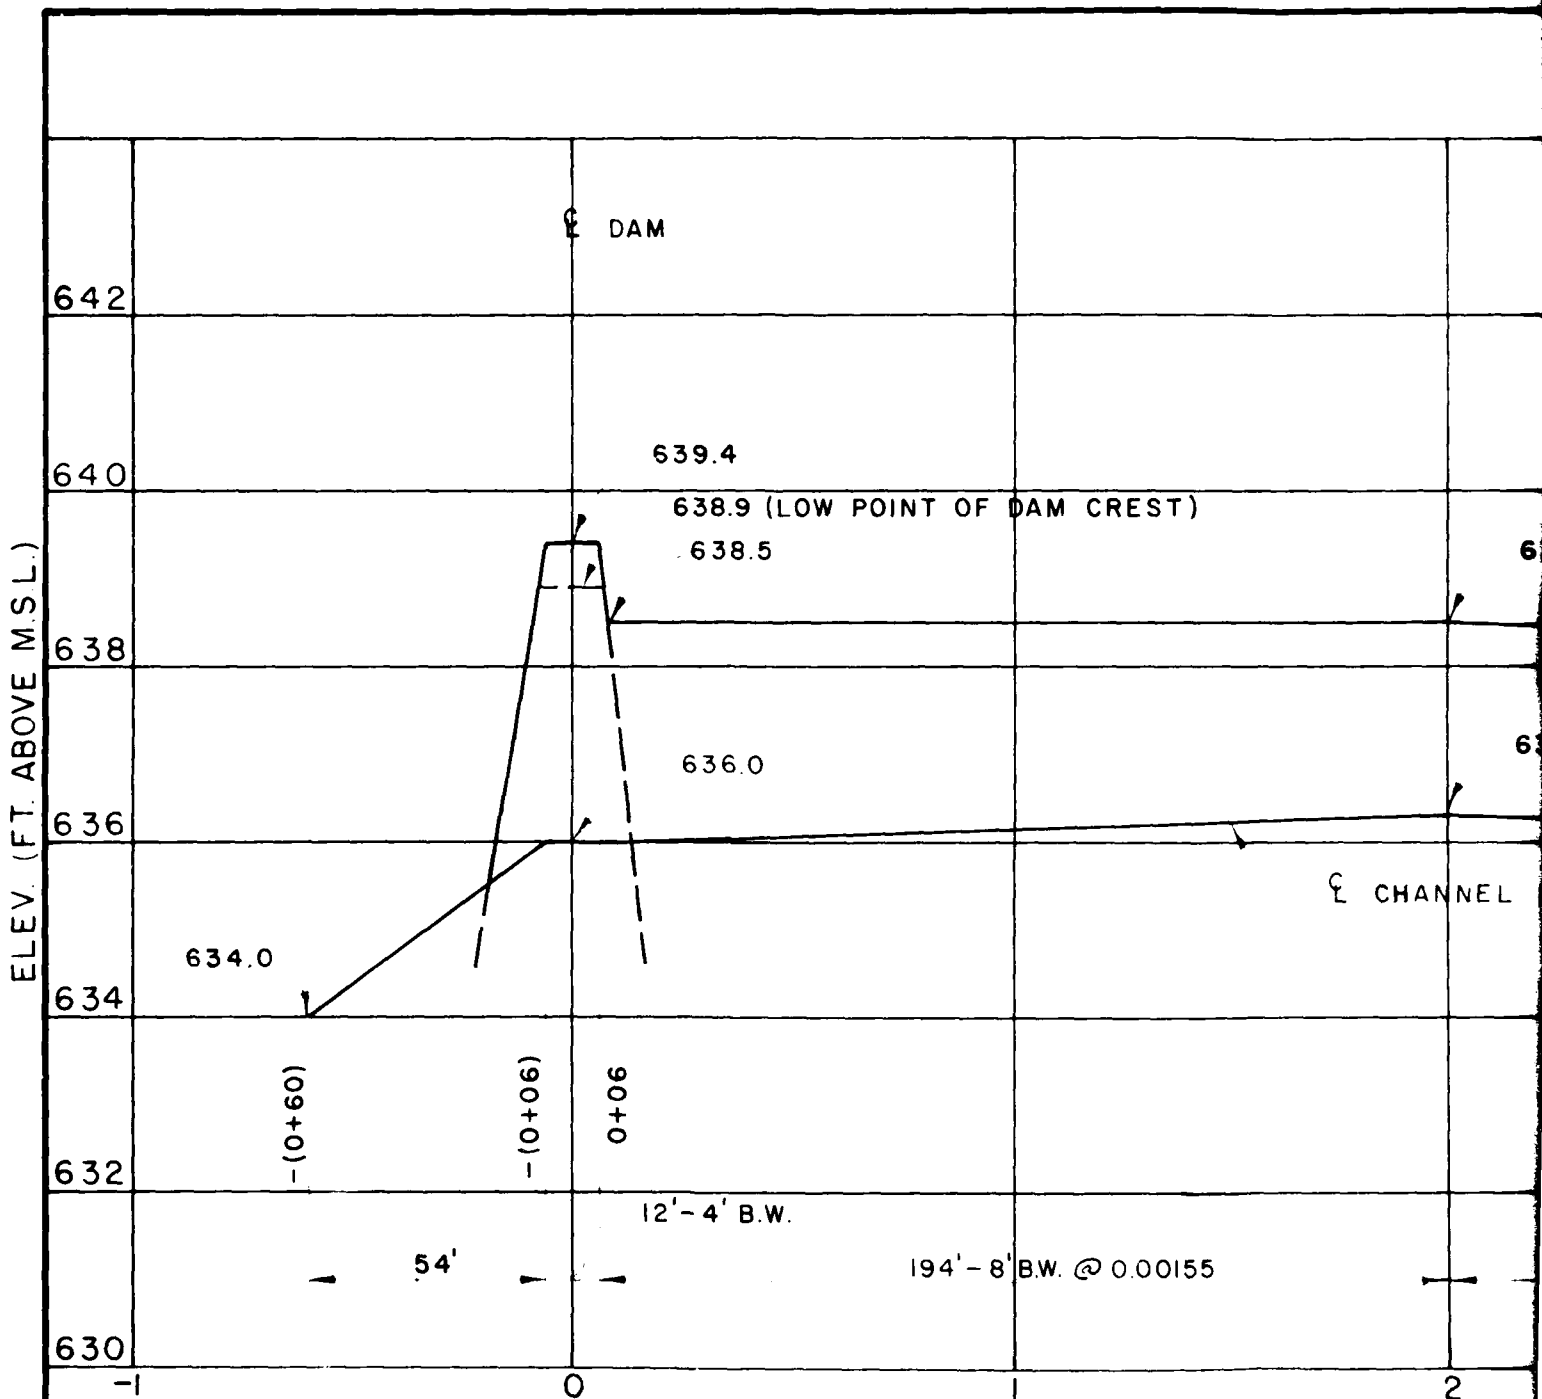
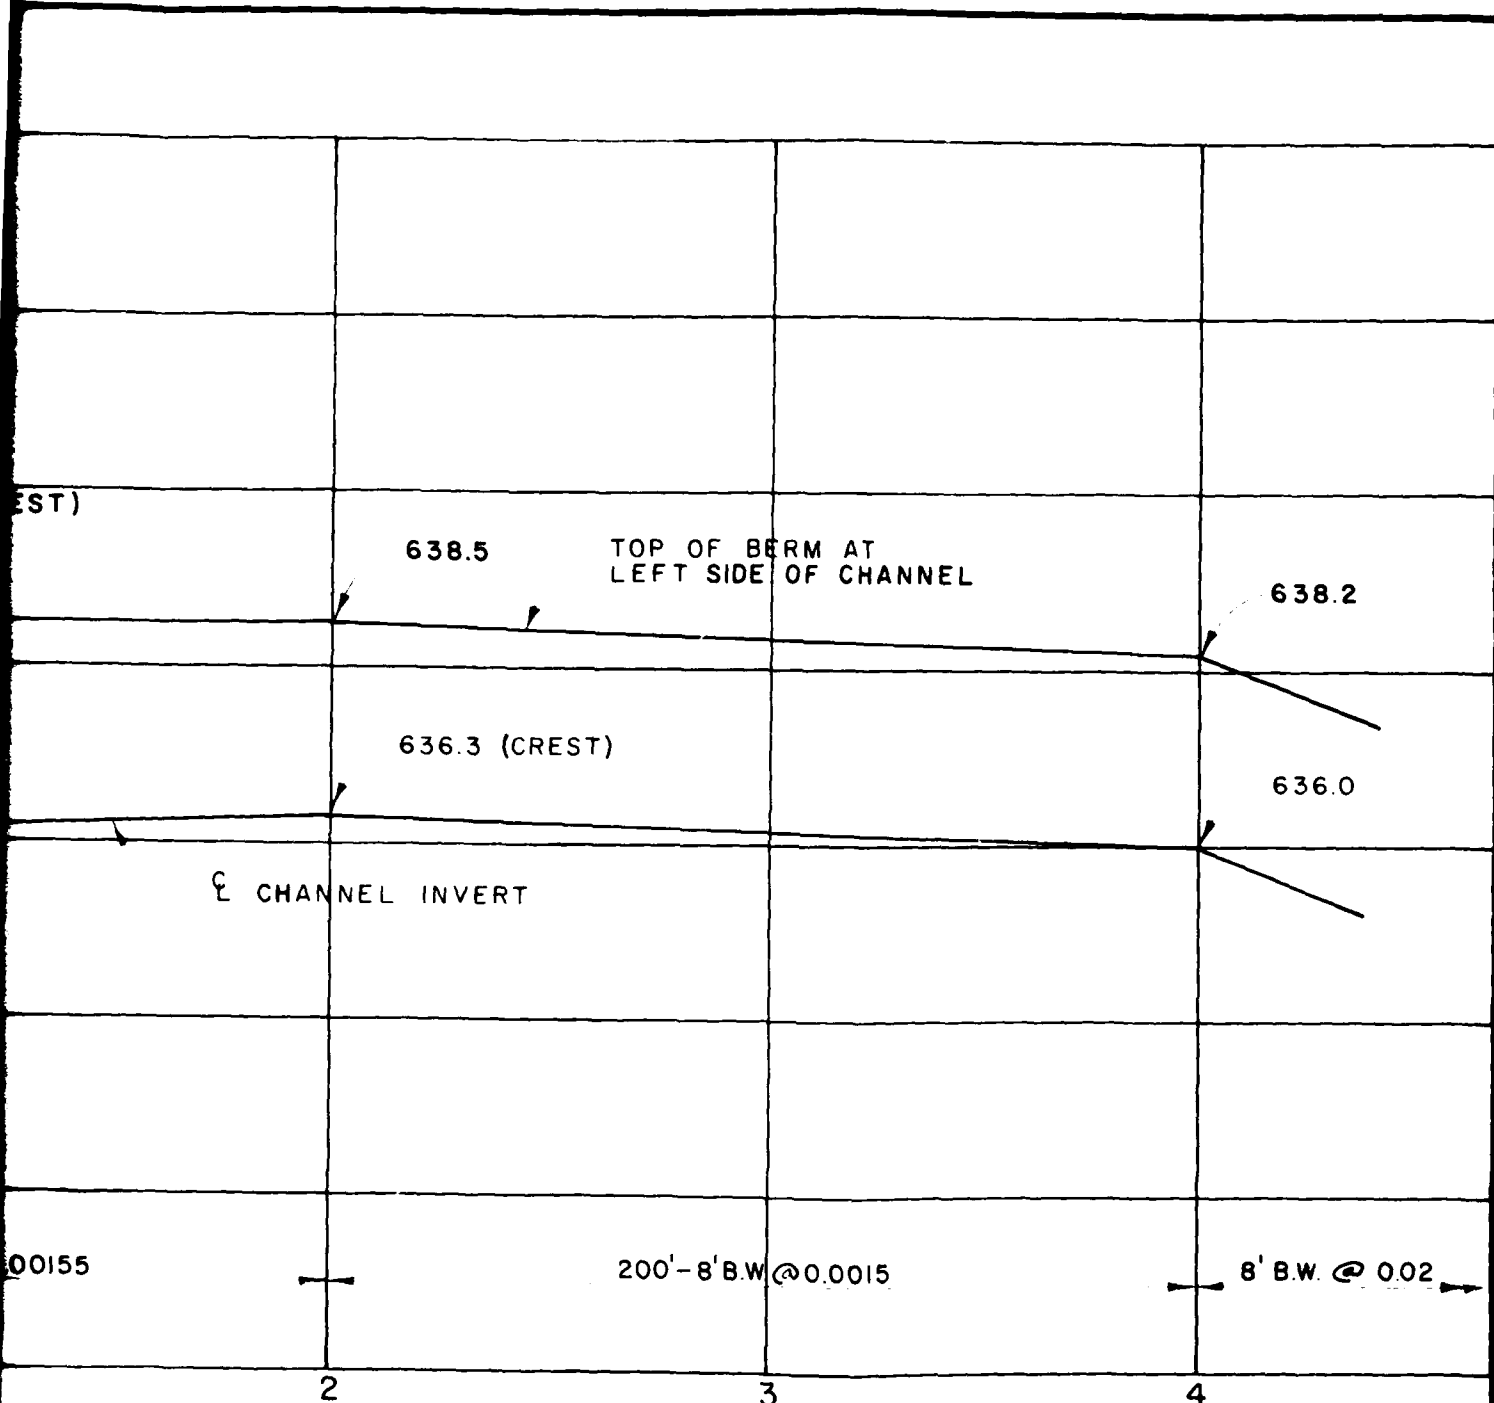
PLATE 5

HICKORY HOLLOW LAKE
SPILLWAY PROFILE

2. As indicated on the spillway channel profile on Plate 5, the crest of the spillway (elevation 636.3) was found to be located approximately 200 feet downstream of the centerline of the dam. The critical section for determination of flow in the spillway channel was assumed to be located approximately 200 feet downstream of the crest. The left bank of the outlet channel adjacent to the dam was found to be approximately 2.2 feet higher than the spillway crest. Spillway releases

greater than 52 cfs were found to overtop the channel bank at the dam. For lake outflow greater than 52 cfs, spillway releases were assumed to be equivalent to the flow passing the outlet channel plus the flow overtopping the channel bank. Flow overtopping the channel bank was determined for various depths corresponding to flows in the channel with depths greater than the top of bank level.
